ARA-TR-00-0041.1-3

Explosive Tests For the Evaluation of the Glass Fragment Mitigation Characteristic of MSC Specialty Films Inc. Security Window Films

August 2000

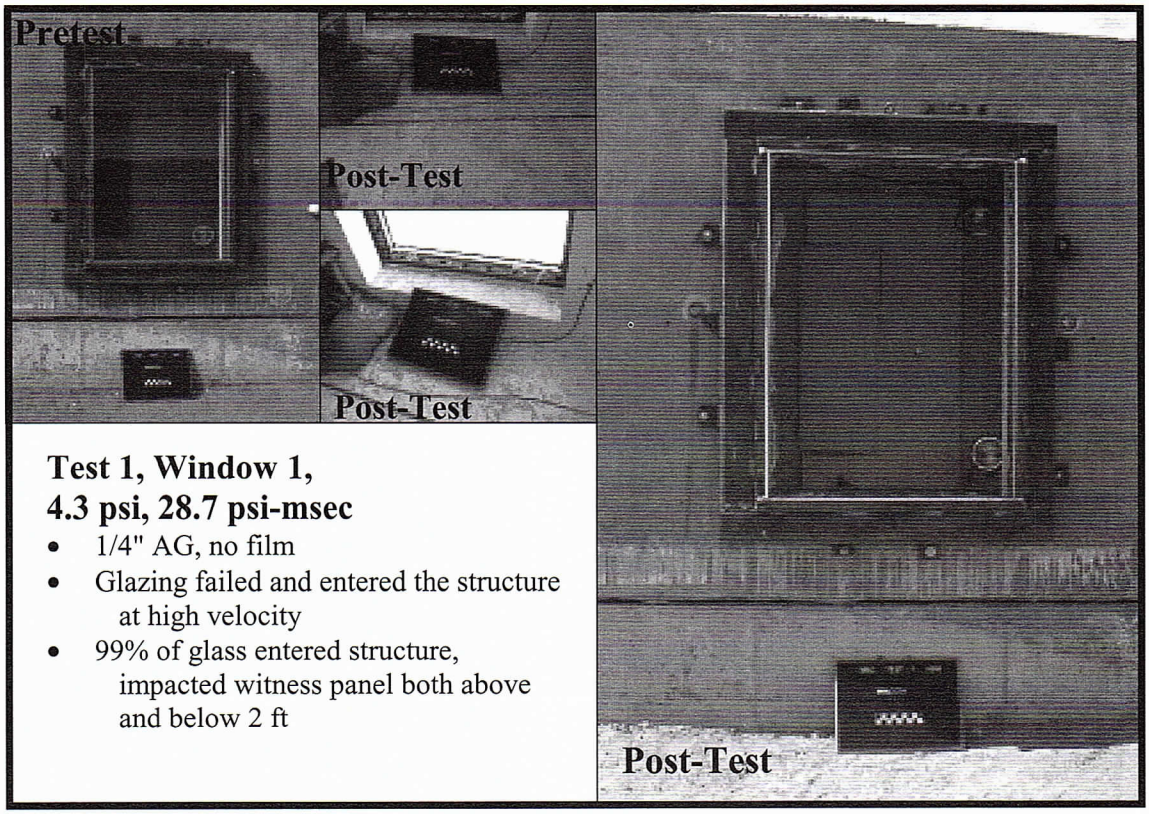
Test 1, Window 1,
4.3 psi, 28.7 psi-msec

- 1/4" AG, no film
- Glazing failed and entered the structure at high velocity
- 99% of glass entered structure, impacted witness panel both above and below 2 ft

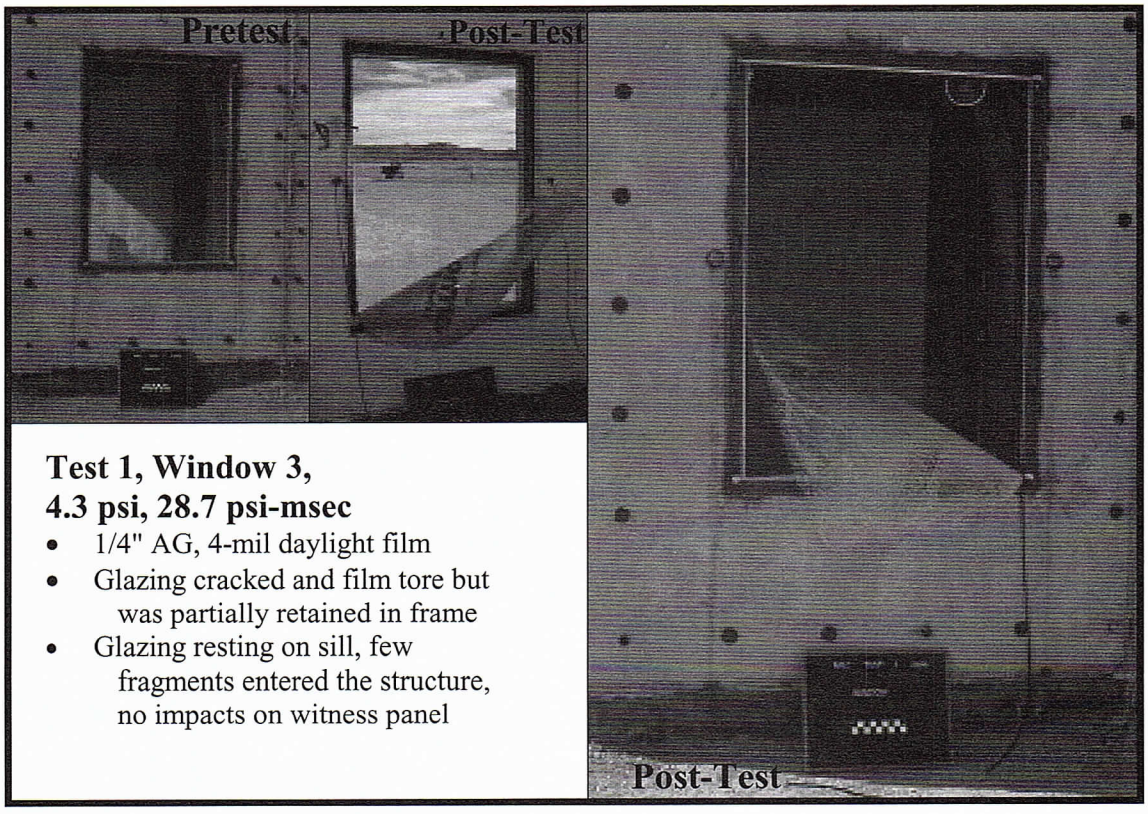
Test 1, Window 3,
4.3 psi, 28.7 psi-msec

- 1/4" AG, 4-mil daylight film
- Glazing cracked and film tore but was partially retained in frame
- Glazing resting on sill, few fragments entered the structure, no impacts on witness panel

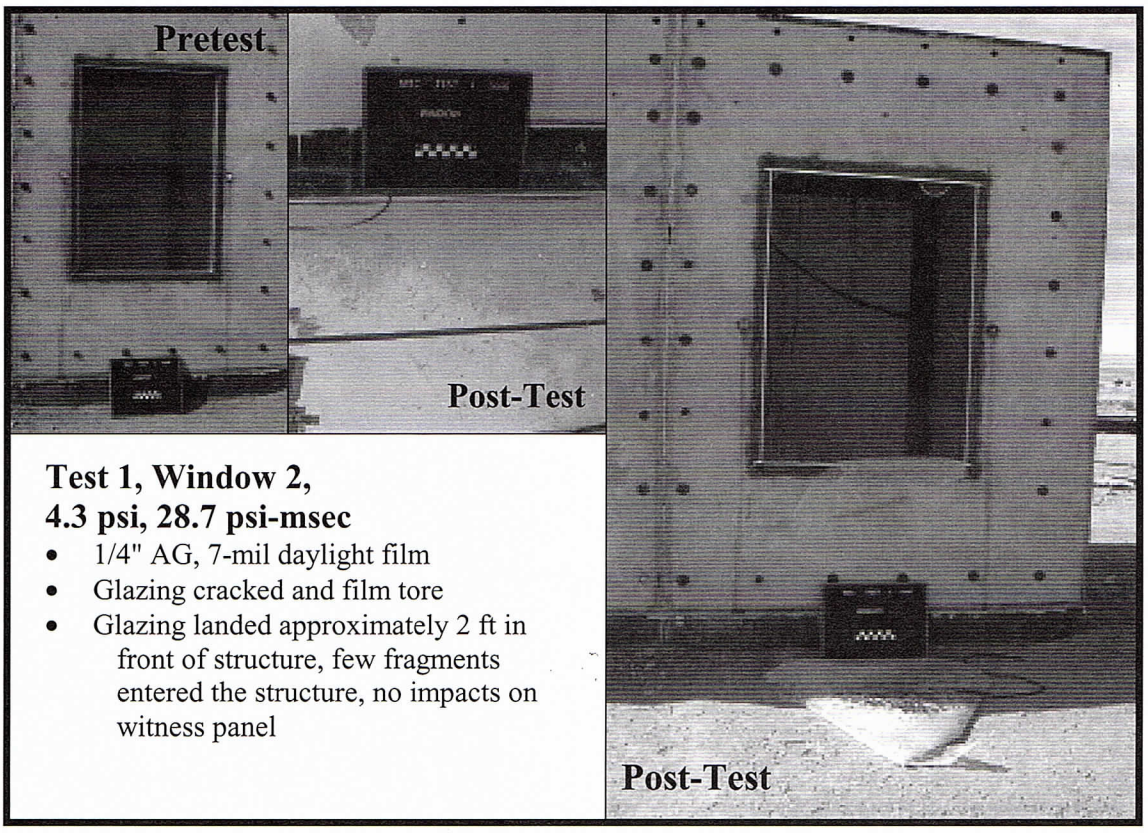
Test 1, Window 2,
4.3 psi, 28.7 psi-msec

- 1/4" AG, 7-mil daylight film
- Glazing cracked and film tore
- Glazing landed approximately 2 ft in front of structure, few fragments entered the structure, no impacts on witness panel

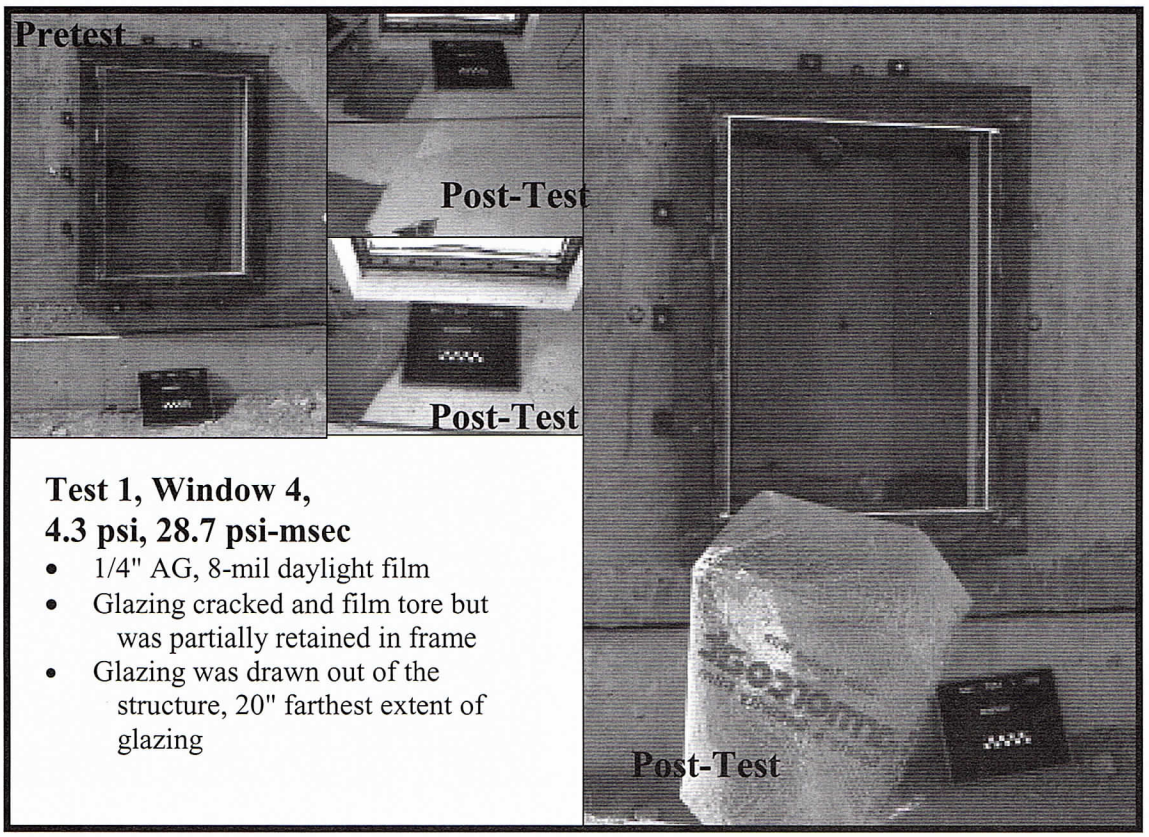
Test 1, Window 4,
4.3 psi, 28.7 psi-msec

- 1/4" AG, 8-mil daylight film
- Glazing cracked and film tore but was partially retained in frame
- Glazing was drawn out of the structure, 20" farthest extent of glazing

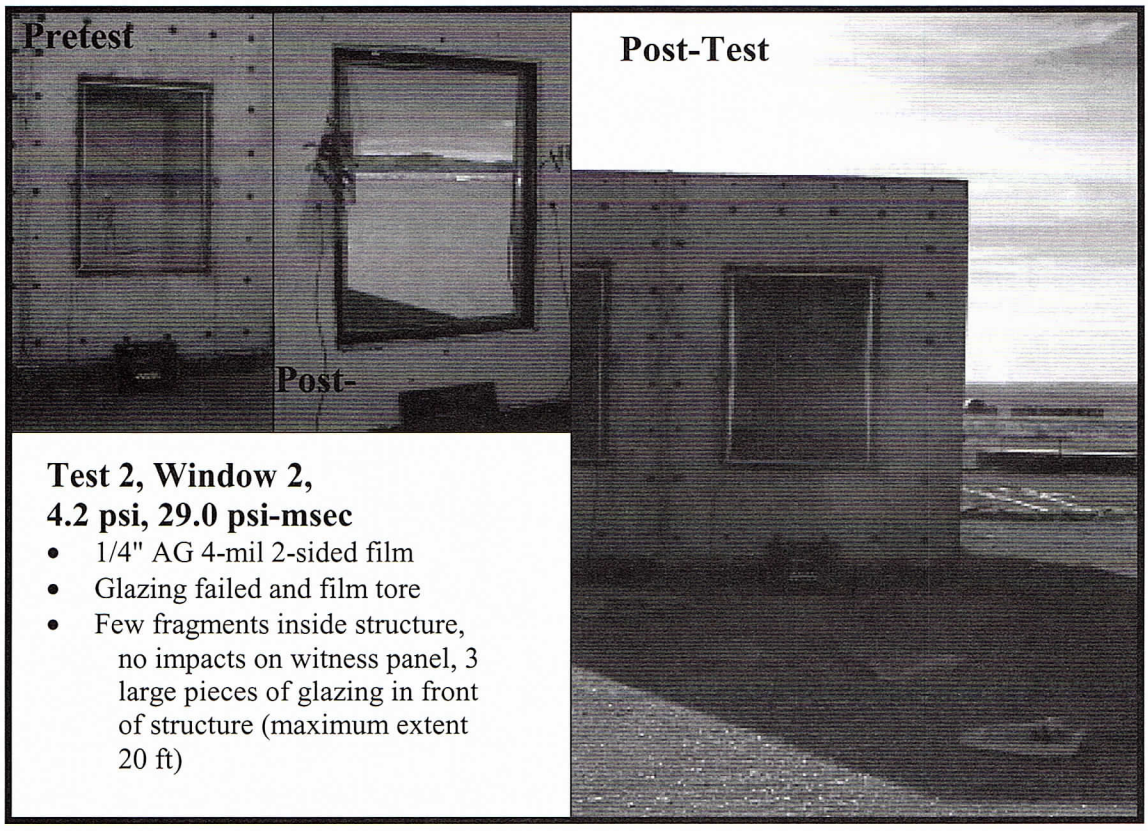
Test 2, Window 2,
4.2 psi, 29.0 psi-msec

- 1/4" AG 4-mil 2-sided film
- Glazing failed and film tore
- Few fragments inside structure, no impacts on witness panel, 3 large pieces of glazing in front of structure (maximum extent 20 ft)

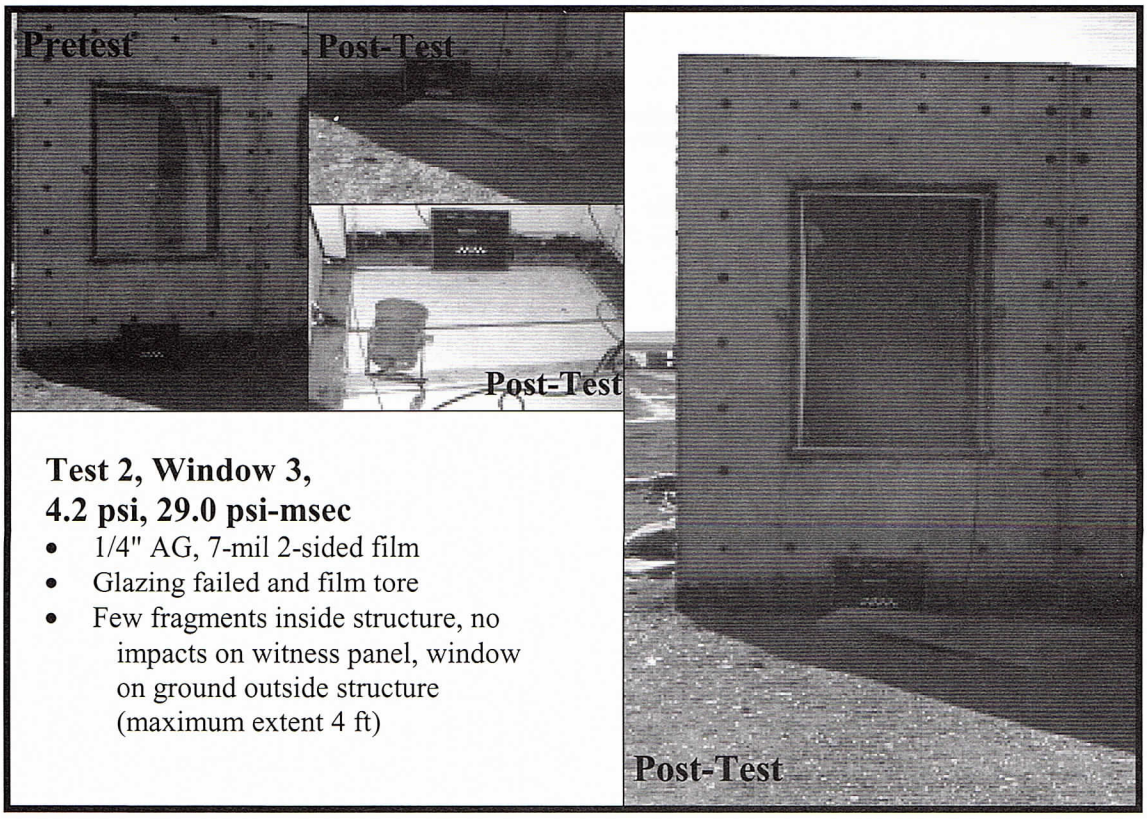
Test 2, Window 3,
4.2 psi, 29.0 psi-msec

- 1/4" AG, 7-mil 2-sided film
- Glazing failed and film tore
- Few fragments inside structure, no impacts on witness panel, window on ground outside structure (maximum extent 4 ft)

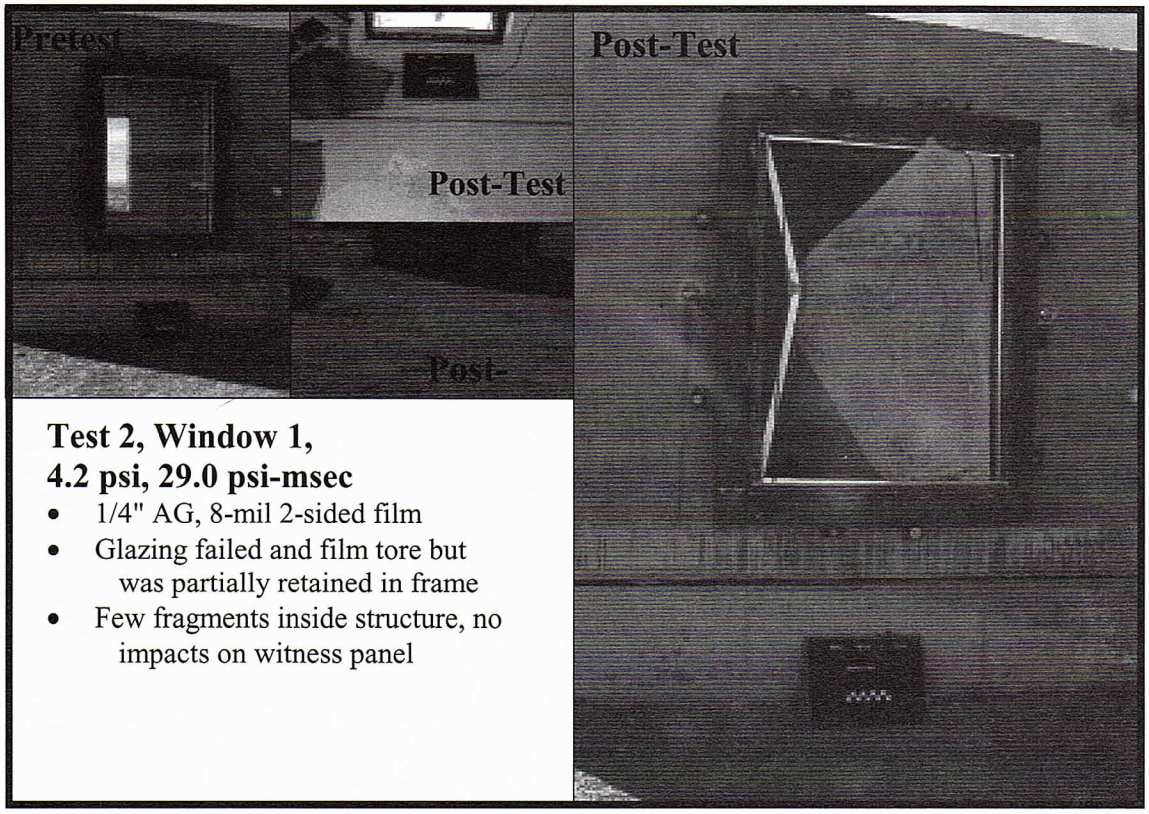
Test 2, Window 1,
4.2 psi, 29.0 psi-msec

- 1/4" AG, 8-mil 2-sided film
- Glazing failed and film tore but was partially retained in frame
- Few fragments inside structure, no impacts on witness panel

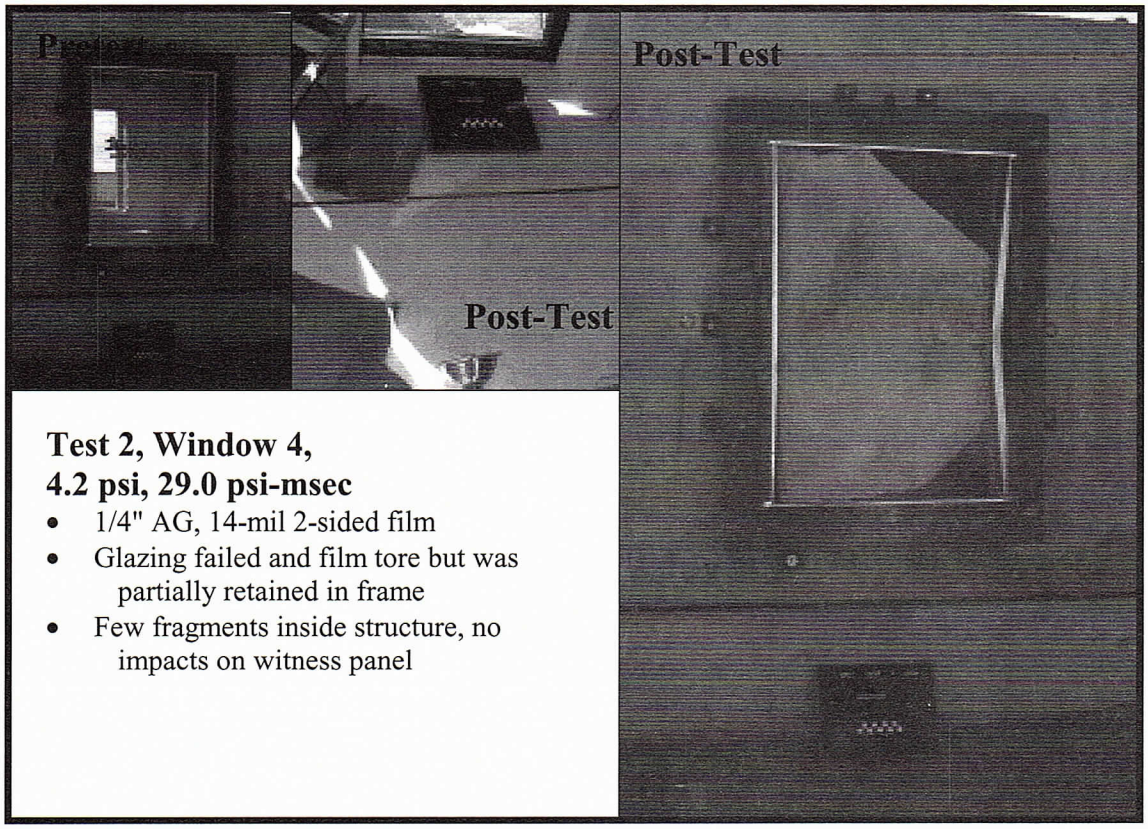
Test 2, Window 4,
4.2 psi, 29.0 psi-msec

- 1/4" AG, 14-mil 2-sided film
- Glazing failed and film tore but was partially retained in frame
- Few fragments inside structure, no impacts on witness panel

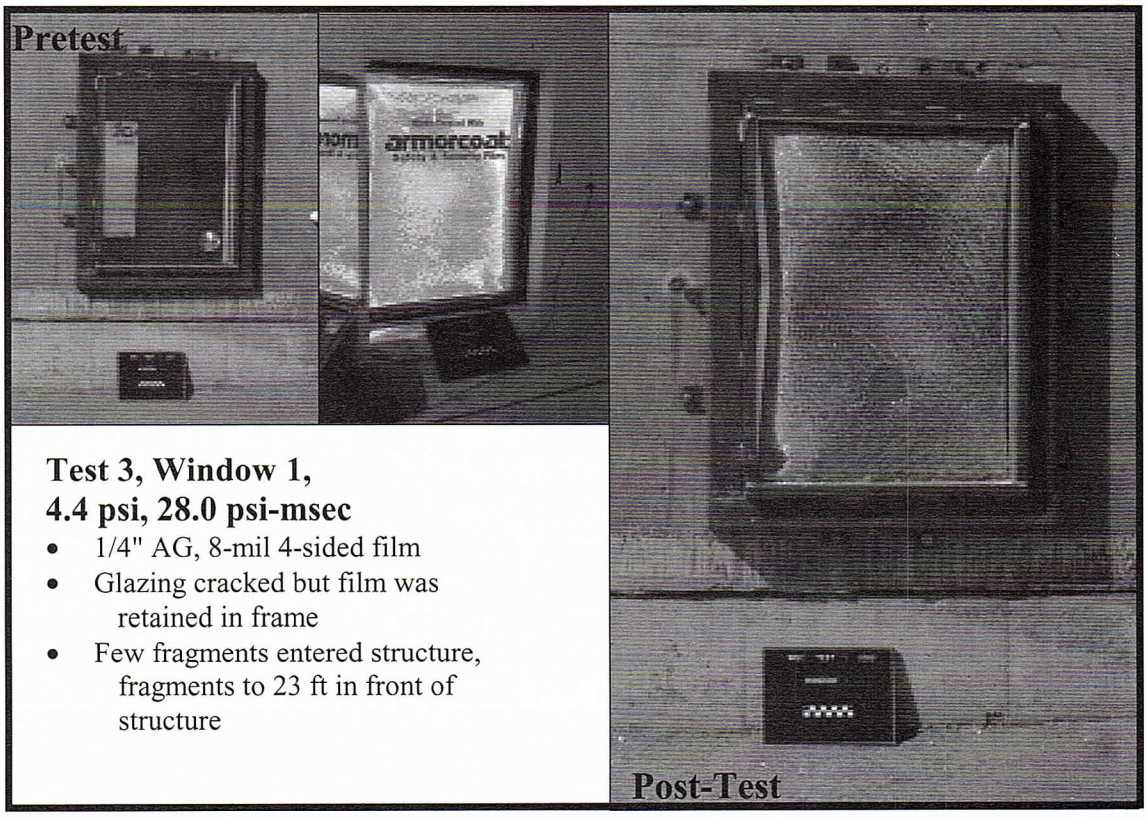
Test 3, Window 1,
4.4 psi, 28.0 psi-msec

- 1/4" AG, 8-mil 4-sided film
- Glazing cracked but film was retained in frame
- Few fragments entered structure, fragments to 23 ft in front of structure

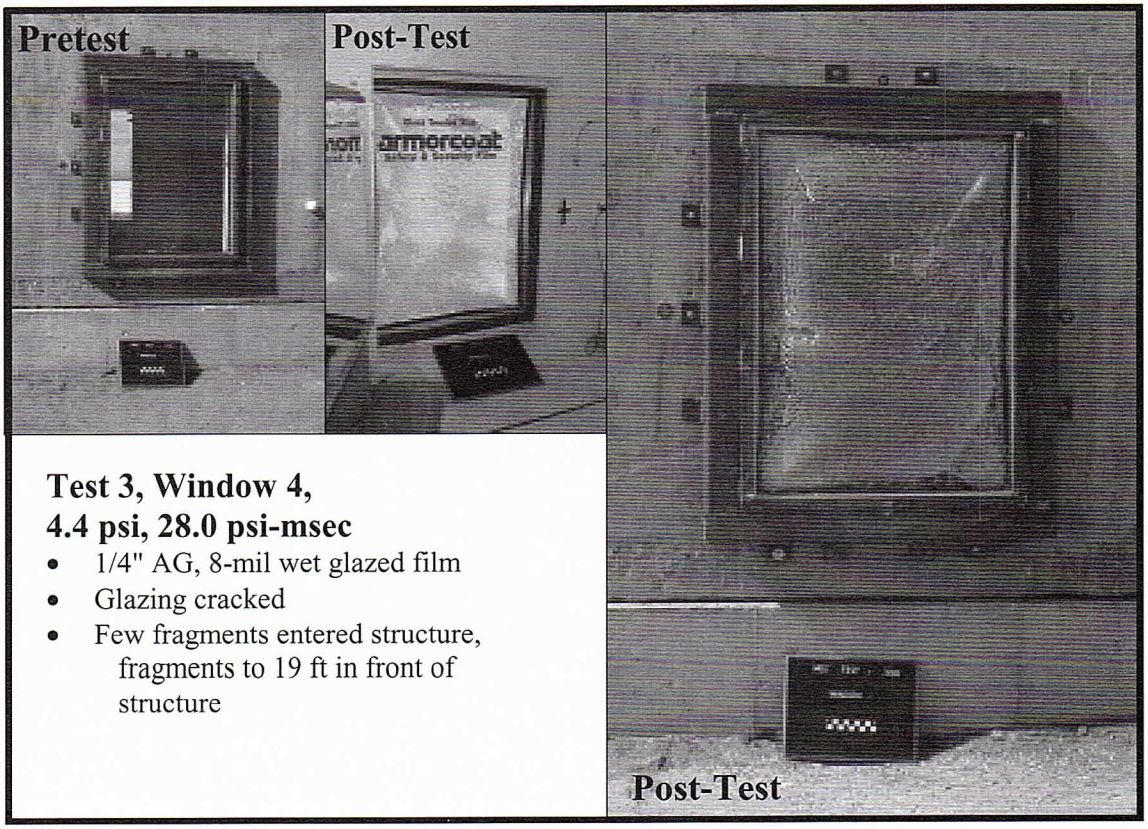
Test 3, Window 4,
4.4 psi, 28.0 psi-msec

- 1/4" AG, 8-mil wet glazed film
- Glazing cracked
- Few fragments entered structure, fragments to 19 ft in front of structure

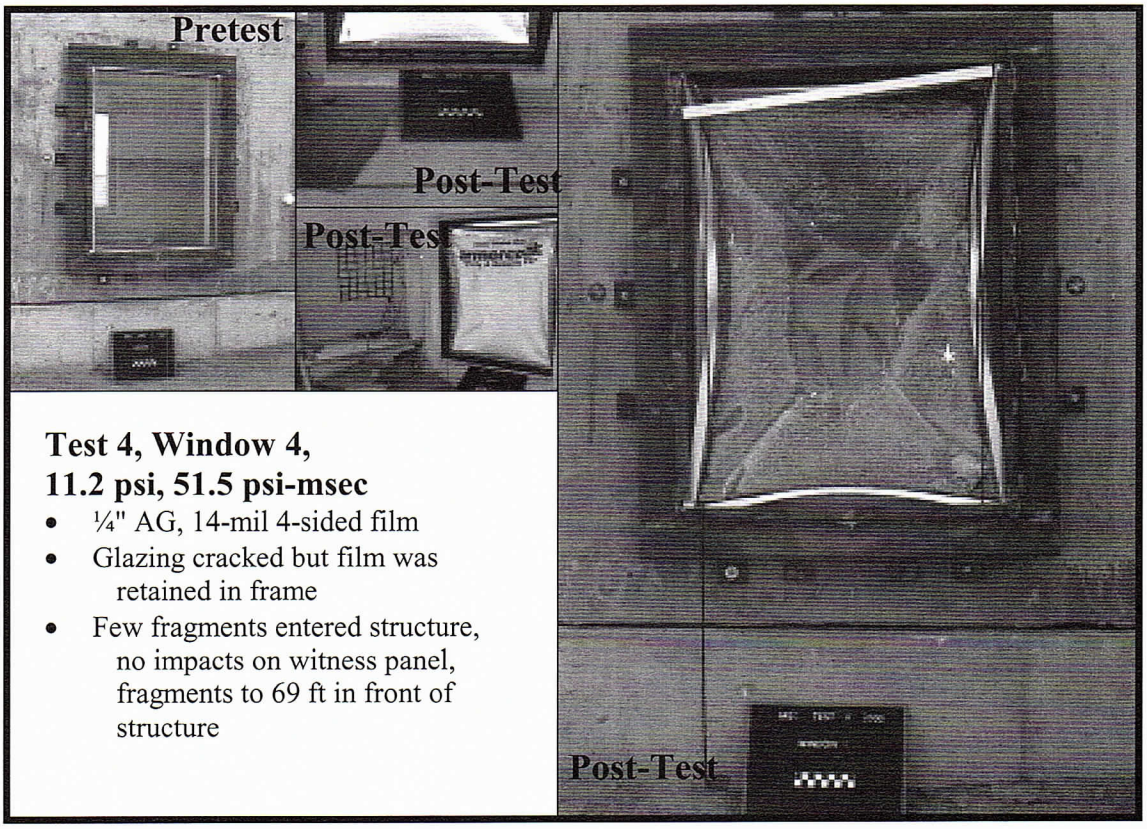
Test 4, Window 4,
11.2 psi, 51.5 psi-msec

- ¼" AG, 14-mil 4-sided film
- Glazing cracked but film was retained in frame
- Few fragments entered structure, no impacts on witness panel, fragments to 69 ft in front of structure
